Contract #: 04-0120F4Cty: SF/ALA Rte: 80 PM: 13.2/13.9File #: 69.28**WELDING INSPECTION REPORT****Resident Engineer:**Pursell, Gary**Address:** 333 Burma Road**City:** Oakland, CA 94607**Report No:** WIR-000906**Date Inspected:** 17-Nov-2007**Project Name:** SAS Superstructure**OSM Arrival Time:** 630**Prime Contractor:** American Bridge/Fluor Enterprises, a JV**OSM Departure Time:** 1530**Contractor:** Zhenhua Port Machinery Company, Ltd (ZPMC), Changxing Island **Location:** Changxing Island

Caltrans Quality Assurance (QA) Inspector, Larry Viars was present to observe the Welding operations of the Caltrans Mock-up # 114 and Orthotropic Box Girder (OBG), for the San Francisco Oakland Bay Self Anchored Suspension Bridge, at Zhenhua Port Machinery Company (ZPMC) facility on Changxing Island.

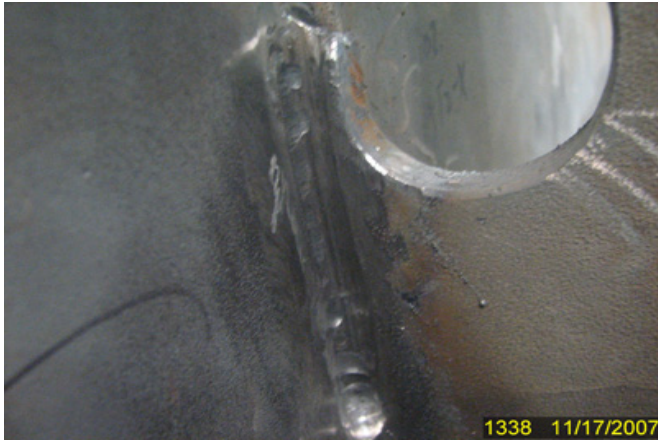
Caltrans QA Inspector observed ZPMC personnel performing FCAW welding of OBG Deck Plate Panel weld trial. Welding was performed on the Closed rib to diaphragm plate. The Complete Joint Penetration portion of the weld was back gouged and visually inspected by ZPMC QC personnel. Please see the attached photo below of back gouged area.
